<b>IP TEST REPORT</b>	
Report reference number:	MTEx 1446/21.0287
Date Tested:	19/07/2021
Date Report was issued:	23/07/2021
Standards.....:	SANS 60529:2013 "Degree of protection provided by enclosure (IP Code)."
IP rating obtained after testing:	IP55 Category 2
Applicant's Company Name .....	CPS Technologies
Applicant's reference.....:	COD
Device.....:	12U "Swing Frame"
Address.....:	James Cres & Suttie Avenue Halfway House Midrand 1684
General remarks: The test results presented in this Test Report relate only to the item or product tested. <ul style="list-style-type: none"> <li>"(see Attachment #)" refers to additional information appended to this document.</li> <li>"(see appended table)" refers to a table appended to this document.</li> <li>Throughout this document, a point "." is used as the decimal separator.</li> </ul> This report/certificate shall not be reproduced except in full.

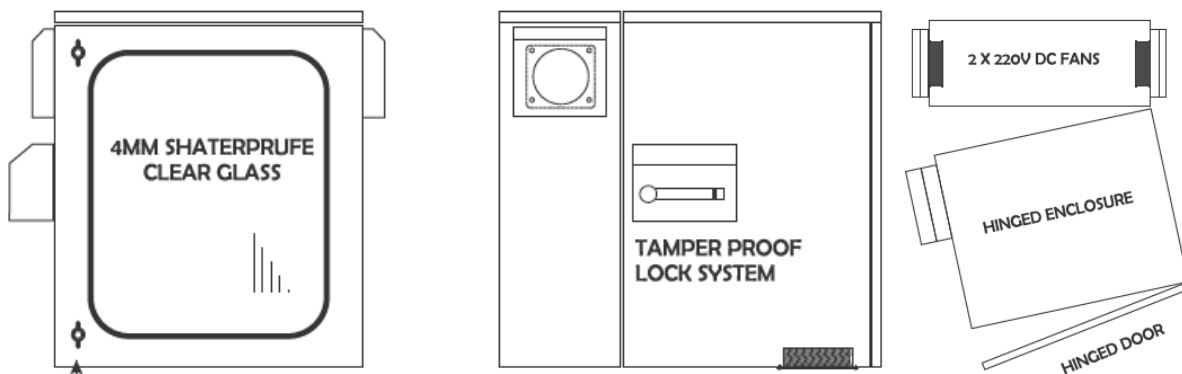
The swing frame enclosure was manufactured by CPS Technologies from 1.2mm mild steel and had a ZN Primer (80 Micron) and RAL 7035 Light grey (80 Micron) finish.

The enclosure had the following approximate dimensions: 649mm (Height) x 563mm (Width) x 670mm (Depth).

The front door had a 4mm shatterproof clear glass window fitted and was closed by means of two 20mm diameter wing nut cam locks.

A tamperproof locking system was fitted to the side of the enclosure to open and close the swing frame part at the back. Foam rubber seals were fitted to the front door and between the main enclosure and swing part at the back.

A microfibre air filter (Model JA1450) was fitted to bottom of the main enclosure, with two fans fitted to each of the two sides of the back swing part for extraction.
